Inspection Report

Property Address:
123 Happy Valley In Ln.
Las Vegas, NV 89012

Lighthouse Property Inspections

Report #: Sample Inspection

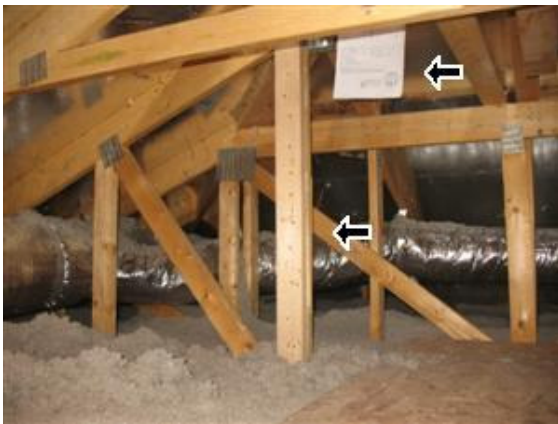
3.0 Picture 1

Repairs were observed to Roof truss web member (supports for engineered roof trusses). This is a Certified repair and approved by a Structural Engineer. FYI

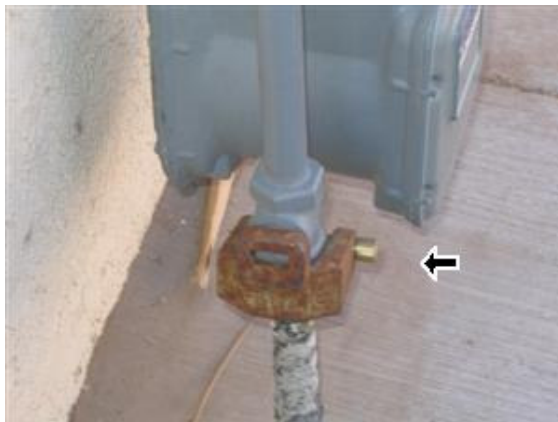
5.4 Picture 1

The Gas supply line was locked off to this property. **Recommend verifying that all utilities are turned on, this will allow the inspector to do a thorough inspection.**

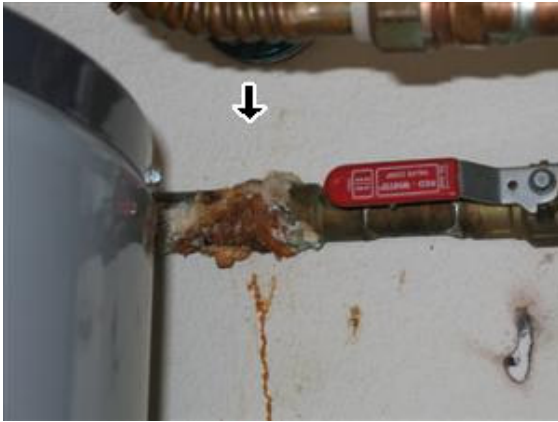
5.5 Picture 1

Corrosion was observed at the Water Heaters supply lines, however there were No visible leaks at this time. Recommend repairing this connection before a Leak develops using a licensed plumbing contractor.

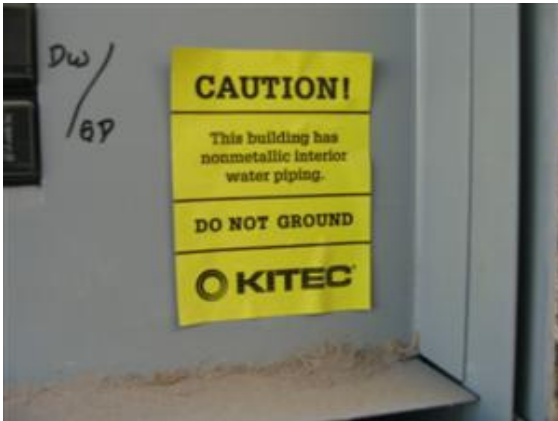
5.8 Picture 1

The plumbing distribution system of this home is Kitec® brand, a product of the IPEX Co. However this was not visually verified by the inspector due to the concealment of the these lines behind walls and under the insulation in the attic area. Please see Attachments at the end of this Report, Or for more information please log on to the Internet @ www.plumbingdefect.com.

Client Advisory: IN THE EVENT that this home is identified as having "PLASTIC" water pipes and Not Copper.

Some types of plastic water piping and their associated connectors and fittings are currently involved, or may become involved, in construction defect litigation due to alleged product failures. Industry experts estimate that more than 50,000 homes in the Las Vegas valley may be affected. If the possibility of this house being involved or the possibility of having to replace the pipes and/or fittings in this home concerns you, I recommend that you contact a licensed, experienced, qualified Nevada plumbing contractor for consultation and further evaluation, before making a final decision on the purchase of this home.

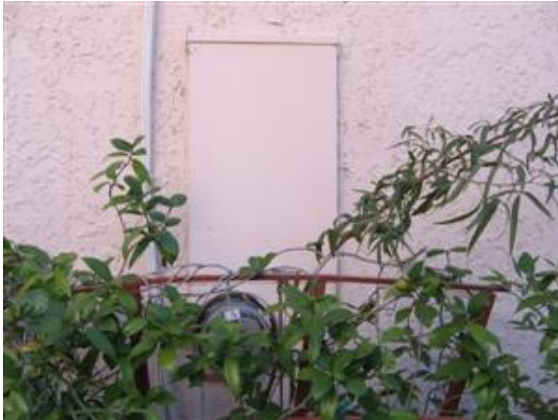
6.0 Picture 1

Vegetation should be cut back to allow reasonable access to Main and Sub electrical panels. **Recommend encouraging the Seller or their Agent to remove obstacles, this will allow the inspector to do a complete and thorough inspection.**

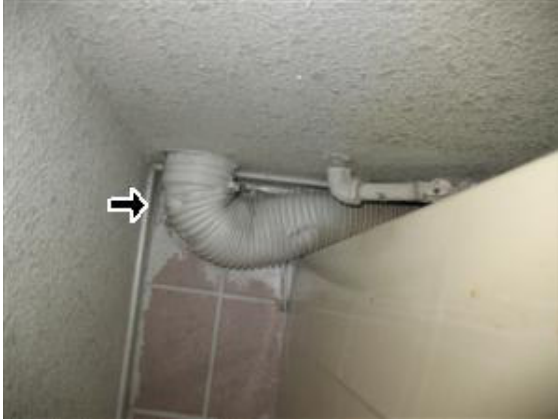
7.8 Picture 1

Recommend checking and cleaning dryer vent upon moving in and at least once a year thereafter. **Your home is equipped with Gas fired appliances, recommend installing carbon monoxide detectors (For Safety).**

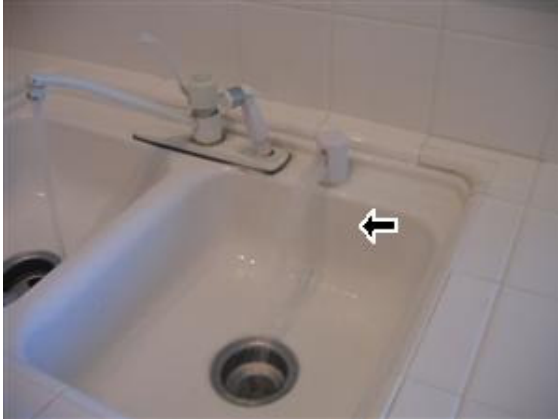
8.0 Picture 1

Dishwasher drain is plugged with evidence of the air gap device discharging water. Therefore the dishwasher was not run through a complete normal cycle. **This is one of the most common conditions discovered in a property inspection. You will want to Clean and clear the drain line for proper drainage of the dishwasher.**

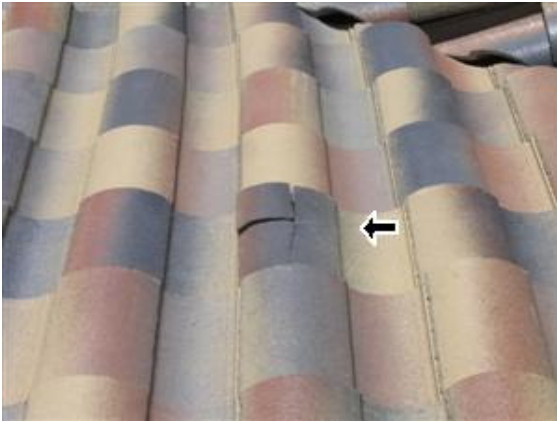
1.0 Picture 1

Damaged to roof tile(s) noted.
